LAWRENCE
LIVERMORE
NATIONAL
LABORATORY

LLNL-TR-648143

A Visual Description of the Concrete Exterior of the Cactus Crater Containment Structure

October 2013

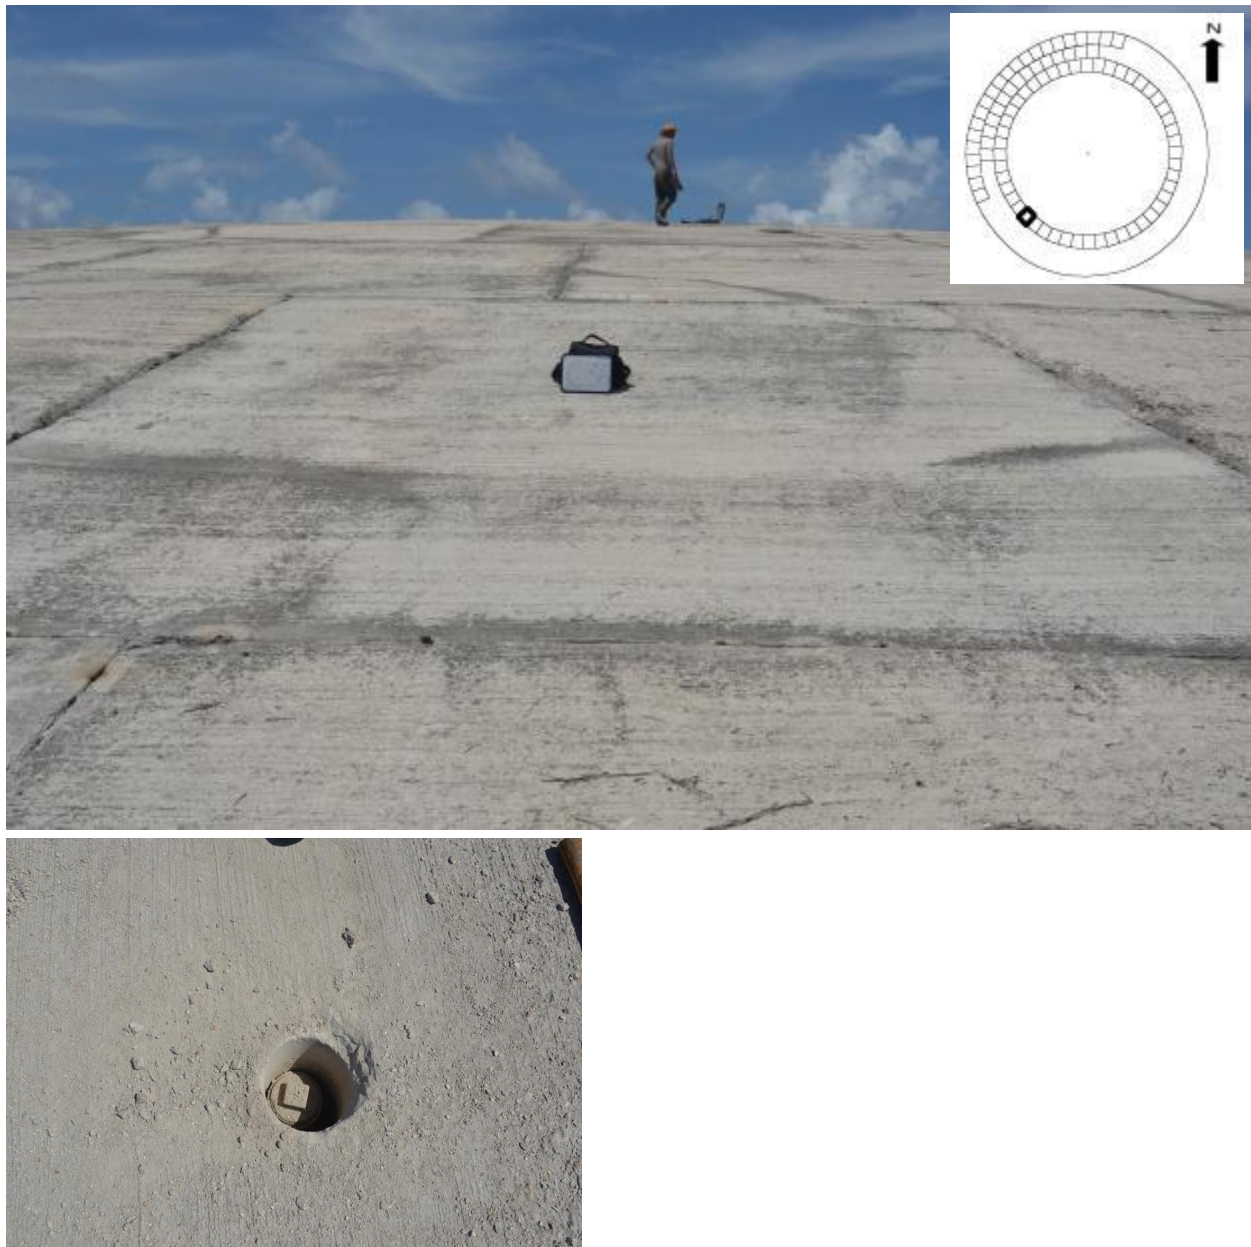
CAP SECTION LOCATION: Panel C36

No significant or obvious interior cracks extending across the top of the panel. Some spalling/cracking of concrete observed in the upper right-hand corner of the panel. Rooting vegetation removed from along the panel seams. This panel contained a capped slotted PVC pipe bore-hole (CD-17) from the 1980 NAS investigation. The bore-hole was re-established during this visual survey for possible use as a groundwater sampling well.

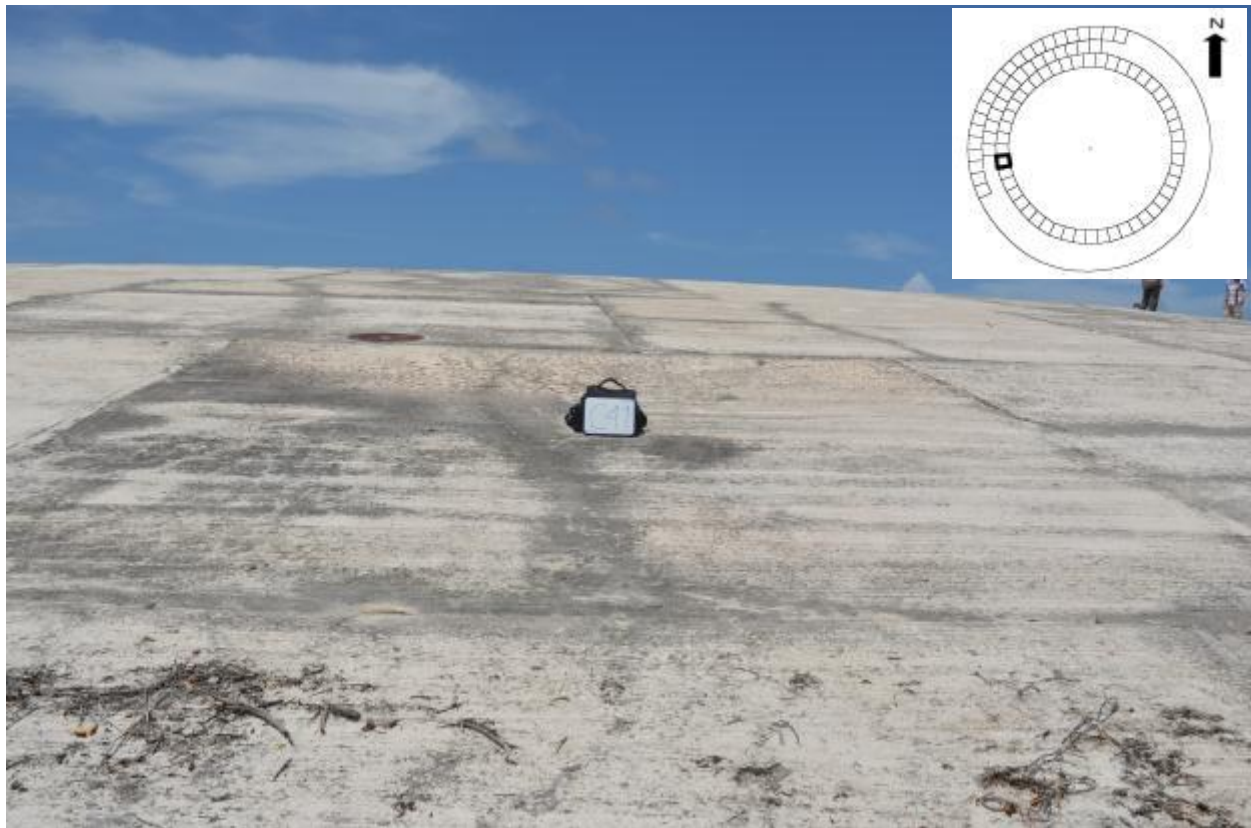
The panel has a rough and weathered appearance across the upper portion of the panel. Some spalling/cracking of concrete observed in the upper left-hand corner of the panel. Rooting vegetation removed from along the panel seams. Surface crack observed extending up from a central location along the bottom seam up to a distance of about 2 meters away from the top of the panel.
